1 Title: My Experience Building a Water System in a Small Rural Community in the Dominican Republic 2 3 Article type: Experience 4 5 Author names: 6 1. Rosemary Wright 7 8 **Degrees and Affiliations:** 9 1. Second year Medical Student. Florida International University Herbert Wertheim College of Medicine., 10 Miami, United States. 11 12 **ORCID** (Open Researcher and Contributor Identifier): 13 1. https://orcid.org/0000-0003-1363-6473 14 15 About the author: Rosemary Wright is currently a second-year medical student at Florida International 16 University Herbert Wertheim College of Medicine in Miami, United States. 17 Corresponding author email: racos062@fiu.edu 18 Acknowledgment: The author thanks Dr. Gary Strandemo and the Saint Cloud Rotary Club for financial and 19 educational support, Henry "Gelo" Belliar for his continuous support throughout the project; the community for 20 allowing me to be part of this project. 21 Financing: The water project was financially supported by the Saint Cloud Rotary Club. 22 Conflict of interest statement by authors: The author has no conflict of interest to declare. The author 23 confirms that this work is original, has not been commissioned, a

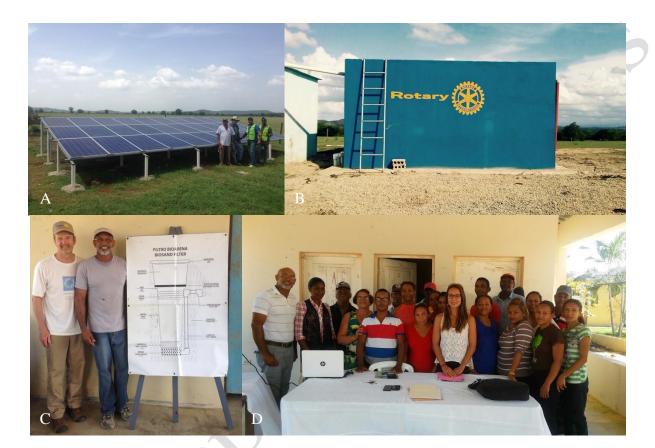
A: Solar panels for electricity generation to pump water from the well. B: The 25,000-gallon water tank to store water for the community. C: Schematic of the Bioarena filters that was distributed to 123 households, the primary school, and the clinic. D: One of the many community meetings to discuss water-related needs.

The water project was divided into three stages. The first stage was the installation of solar panels in a large field in Sabana Larga to retrieve solar energy to capture solar energy for generation of electricity (**Figure 1A**). This electricity was used pump water from an already existing well 140 feet below ground. The water from the well was pumped to a newly built water tank described below. The solar panels were purchased in the nearby city of Dajabon and were transported and assembled by local community members.

The second stage was the placement of a 25,000-gallon water tank to provide sufficient water for the growing population of Sabana Larga (Figure 1B). The tank was equipped with valves and piping to each home. All the materials were purchased in one hardware store located in the city of Dajabon. All the items aligned with the local culture and technology available. The water tank was designed by local engineers and was constructed by community members. The Saint Cloud Rotary Club came to Sabana Larga in June 2017 for one week to help with the construction under the supervision of the engineers.

The third stage was the distribution of the water filtration systems to each household, the primary school, and the clinic **(Figure 1C)**. Bio Arena, a Dominican company located in Dajabon, installed 125 water filters in 123 households, the primary school, and the local clinic. Prior to the distribution of water filters, most homes purchased water in plastic jugs or "botellon" from large trucks that pass by every other day. Each botellon holds five gallons and costs 150 pesos (~2.70 USD) for a new bottle or 40 pesos (~0.72 USD) for a refill. Each household used at least one botellon a day and the cost of such purchases represented a financial burden for many families. Households that were not able to afford the botellon instead used river water for drinking, introducing associated health risks.
